PROJECT PROFILE

- Project:** Interior Floor Raising – Frontier Airlines Center, Milwaukee, WI
- Contractor:** CRC Concrete Raising Corp of Wisconsin
- Classification:** Commercial Floor
- Project Scope:** Core drilling and Grouting of 38,016 square feet of interior floor; After pre-scan of floor for buried conduit and junction boxes, determination of injection hole placement (by CRC) and subsequent carpet cutting; Prior to carpet re-gluing
- Project Completion:** October, 2012 – 5 workdays to complete

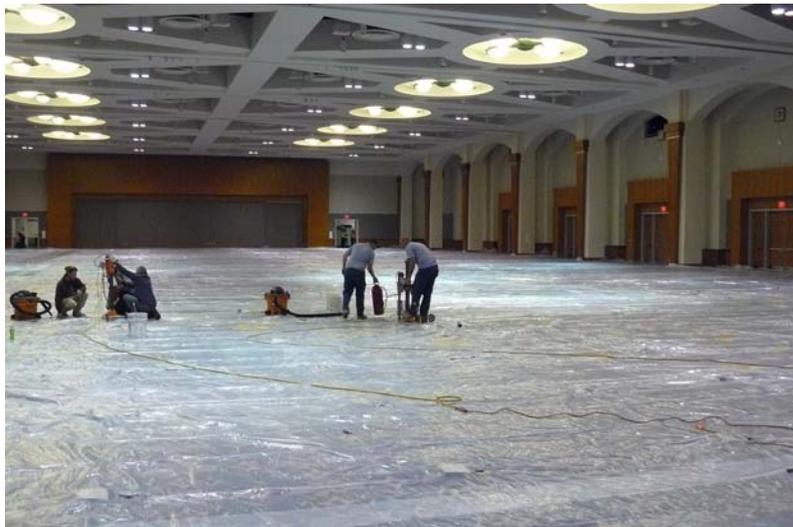
Above: CRC crews work to core drill strategically-placed grouting injection holes within the main ballroom areas of the Frontier Airlines Center. Plastic sheeting appears over the carpeted ballroom floor. Flaps were cut in the carpet for grout injection holes.

Prior to the core drilling of the grout injection holes, all ballroom partitions were opened, creating one main work area. A scan was conducted to locate all wiring and communications conduit, as well as any junction boxes to determine exact conduit locations located within/beneath the slab-on-grade interior floor. Plastic sheeting was placed atop the carpeting, which had tape marks placed throughout, to provide visual reassurance as to where carpet flaps should be cut and grout injection holes to be placed.

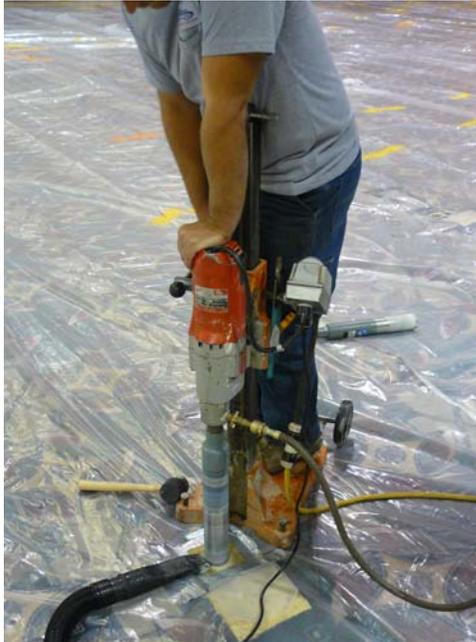
Above: CRC crews core drill strategically-placed grouting injection holes within the main ballroom areas.

Initial core drilling took place over the course of the first full day and saw no less than four (4) core drills, each equipped with vacuum hoses to reduce dust particulates, operating within the work area at one time. The structural integrity of the floor itself was sound, and floor thickness was generally found to be in the range of twelve-and-one-half to fourteen (12.5-14) inches, as verified by the actual cores removed.

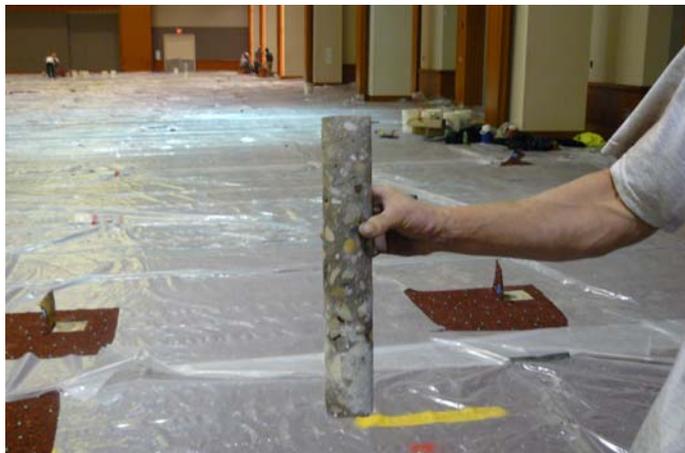
Above: A 14-inch core taken from the interior floor of the Frontier Airlines Center.

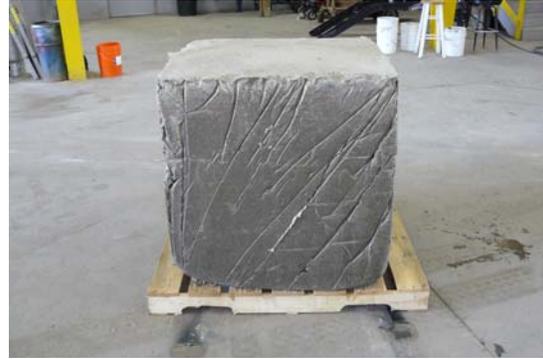
Above: A 3-ft by 3-ft by 3-ft (1 cubic yard) sample of the specified cement grout. As standard protocol, contractors are often asked to demonstrate calibrated settings. Note the completeness of the void fill and consistent nature of the grout produced by CRC's volumetric mixers.

CRC's volumetric mobile mixers were calibrated to produce the specified 329-lb/yd³ cement grout (see picture, next page). Volumetric mixers are designed to produce material on-site and on-demand, to ensure fresh, consistent, calibrated material for each and every job. Such mixers are capable of producing sixty (60) cubic yards of material per hour.

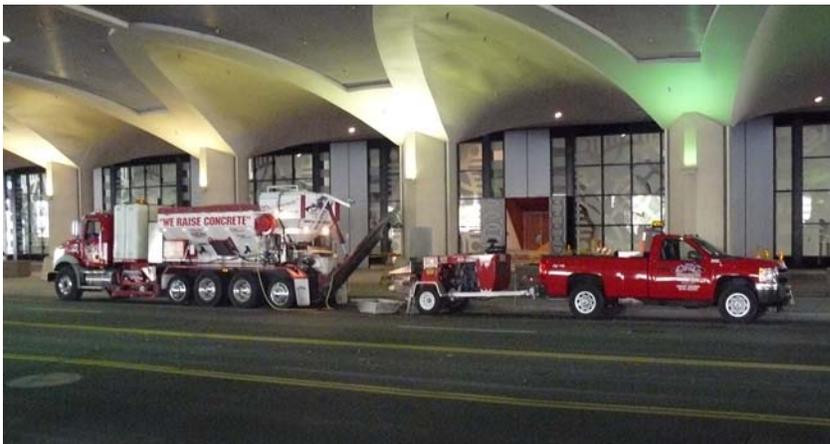
Above: A CRC volumetric mixer is shown producing fresh grout at the Frontier Airlines Center. The grout was being mixed into a 60-yard concrete pump (shown at the back of the work truck) and pumped to the interior ballroom, where the line was reduced and the material injected.

Beginning on Day 2, in order to meet the unique demands of the job, CRC mobilized two (2) different style pumps: a single-piston "mud pump", modified to run off of propane to allow for interior work without concern for indoor air quality and/or ventilation of pump exhaust, and a larger concrete pump (rated at 60 cubic yards of material per hour) to accommodate void filling in a time-efficient manner through hoses extending in excess of three hundred and fifty (350) feet in length.

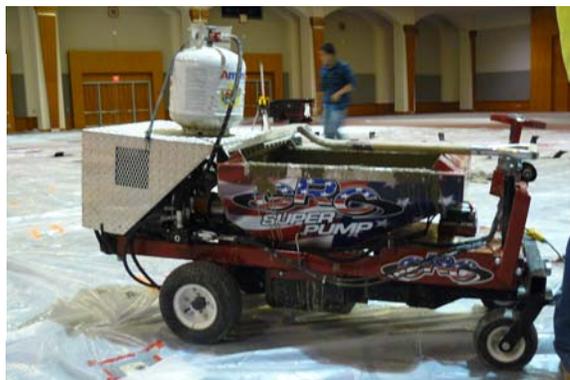
Right: A CRC single-piston pump, with a propane conversion apparatus is used to inject grout inside the Frontier Airlines Center in early October, 2012.

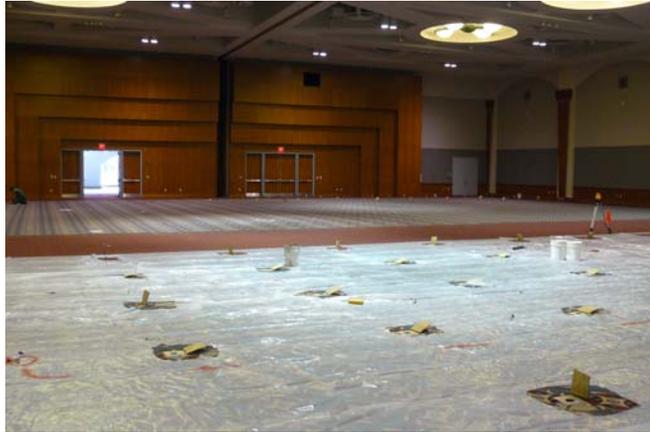
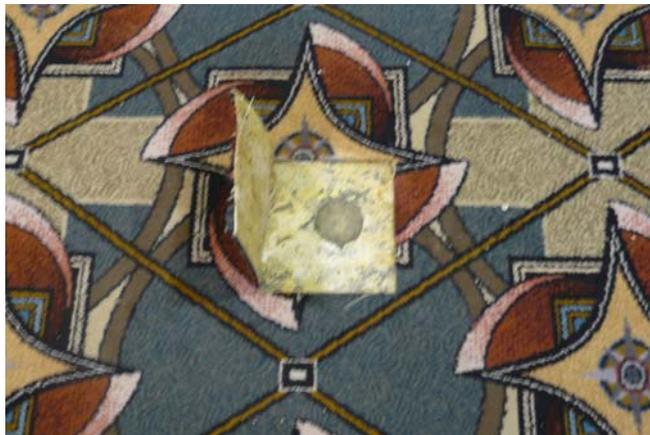
Additional core drilling took place again on Day 3, as CRC had finished injection grouting the East Hallway Corridor, as well as Ballrooms A and B the day previous. During drilling operations, CRC personnel began patching the completed injection holes with prescribed patching material (sand-cement mix) and plastic sheeting was removed from the grouted areas, so that carpeting professionals could begin re-gluing the carpet flaps down (shown in pictures, at right).

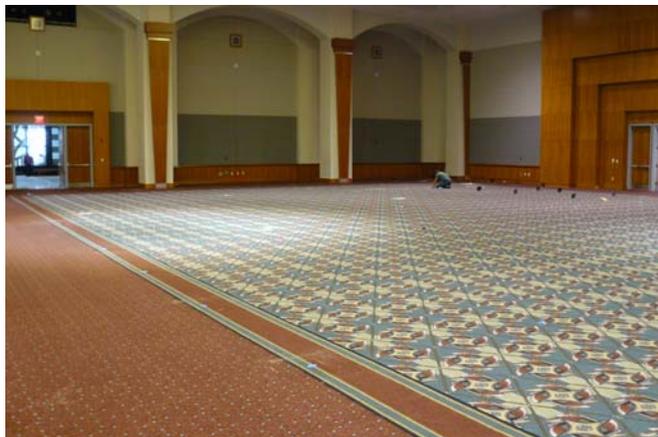
On Days 4 and 5, core drilling was completed and Ballrooms C and D, plastic sheeting was removed, holes patched, and carpet flaps re-glued to their original position.

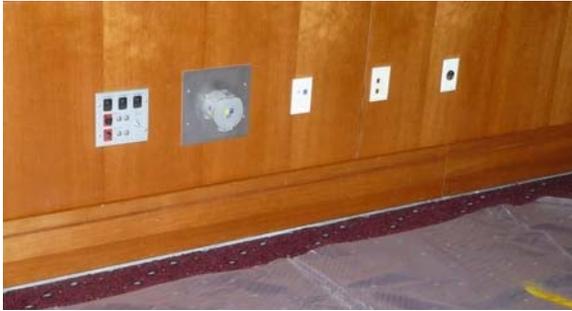
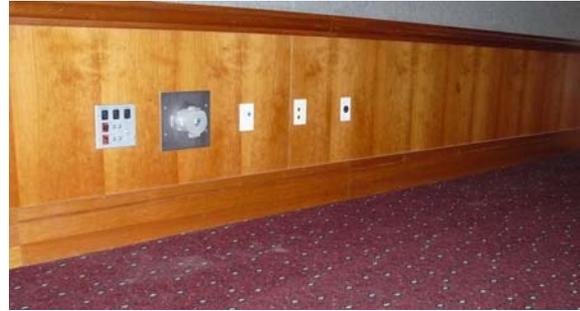
Above: (Left) A picture showing the settlement of the carpeted floor at the Frontier Airlines Center just prior to raising by way of calibrated cement grout. (Right) A picture taken immediately following the grouting process performed by CRC Concrete Raising – note that the wall no longer has a one-and five-eighths (1 5/8) inch “gap” at the base.
